INVESTIGATION OF HYDROTEST FAILURE OF THIOKOL CHEMICAL
CORPORATION 260-INCH-DIAMETER SL-1 MOTOR CASE

By John E. Srawley and Jack B. Esgar

Lewis Research Center
Cleveland, Ohio

in Collaboration with the
260-SL-1 Hydrotest Failure Investigating Committee

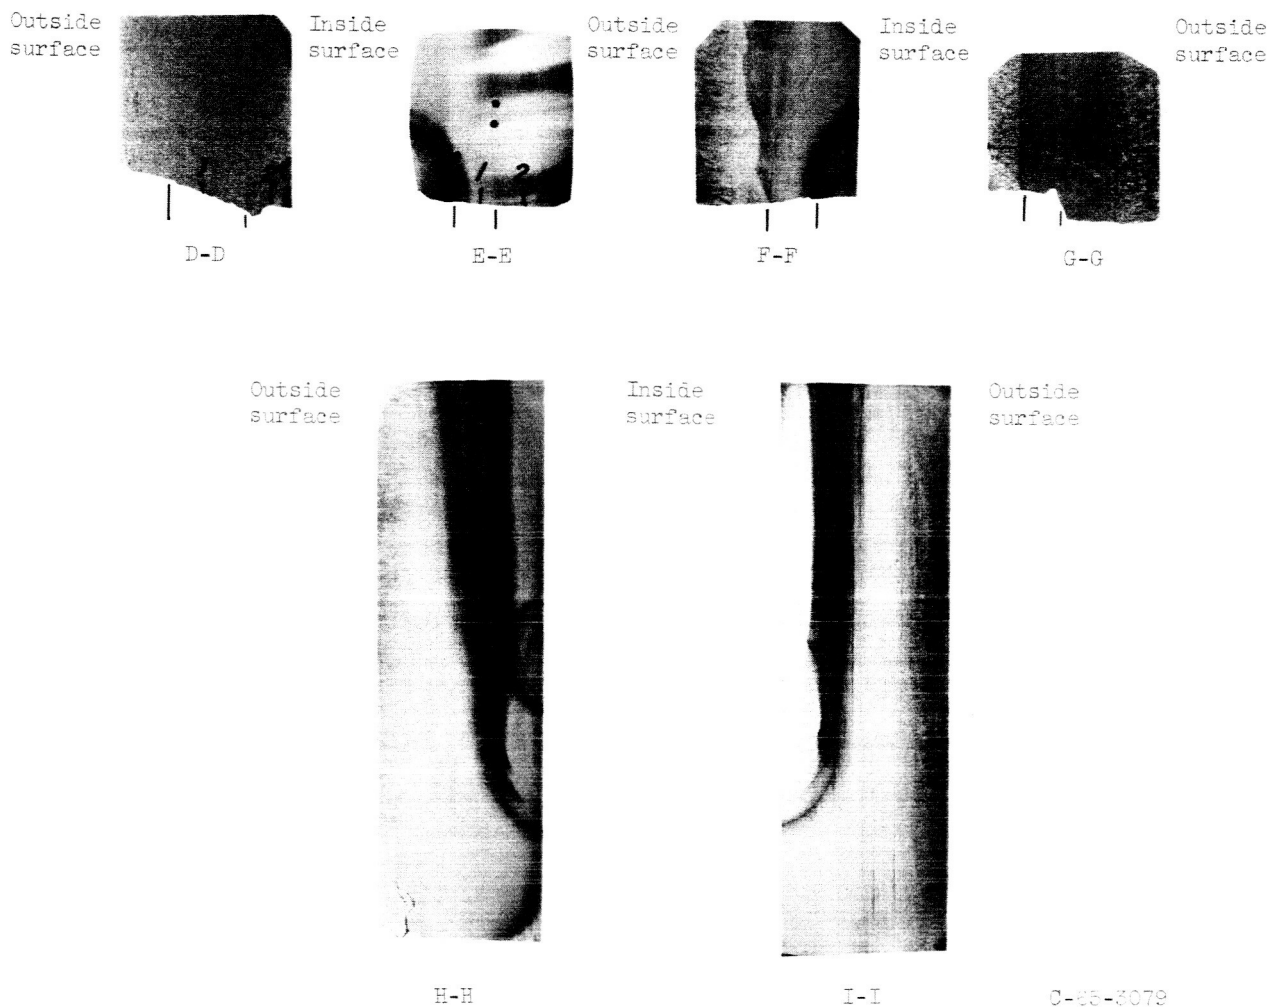
Figure 27. - Cross-sectional views through black defect region (see fig. 25). $\times 1.5$.
(Reduced 17 percent in printing.)

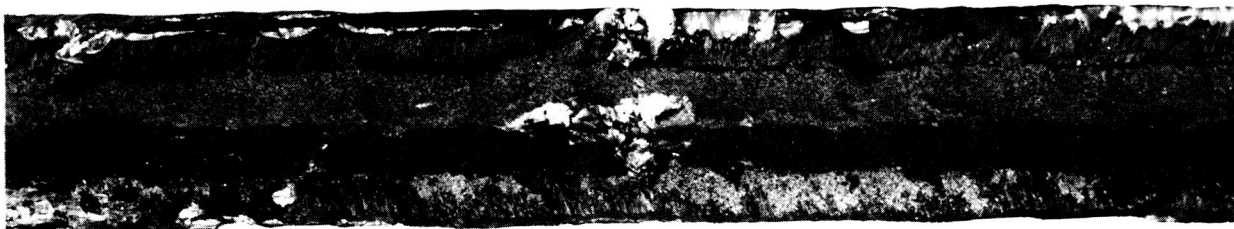
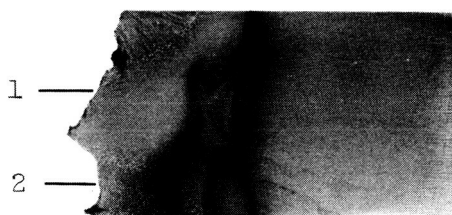
Figure 31. - Photomacrographs of fracture path along weld W7/302 between clean and black defects. $\times 1.5$.
